Replacing the Speedometer and Clock in a 3.0CS

Photos and text by Michael Thompson

This procedure was done on a 1972 3.0CS USA model with A/C and electric windows. Yours will be a little different even if it is the same model and year as mine...

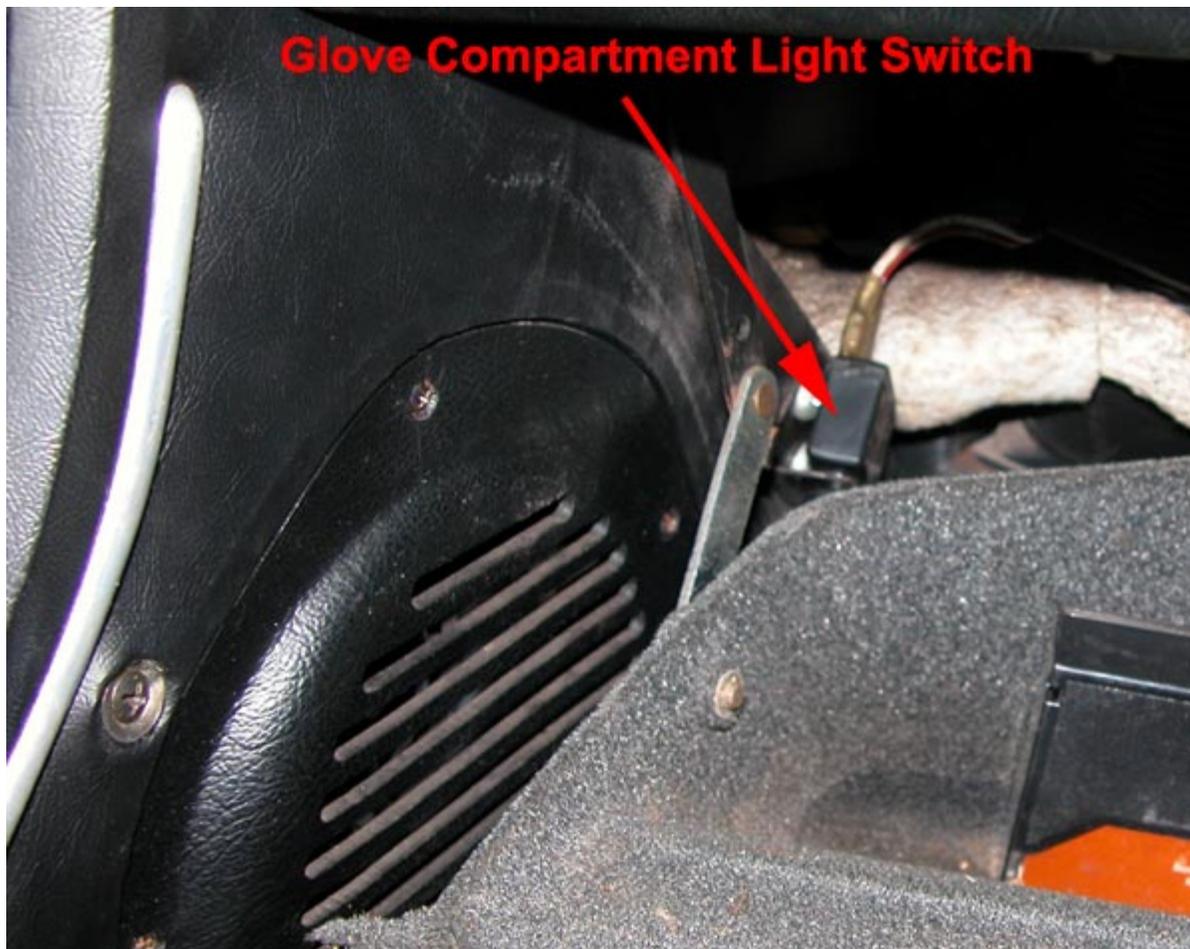
You need to remove the glove compartment light switch. I pulled both wires so the light would not stay on. There is a plastic nut that holds the switch to a bracket on the right console side.

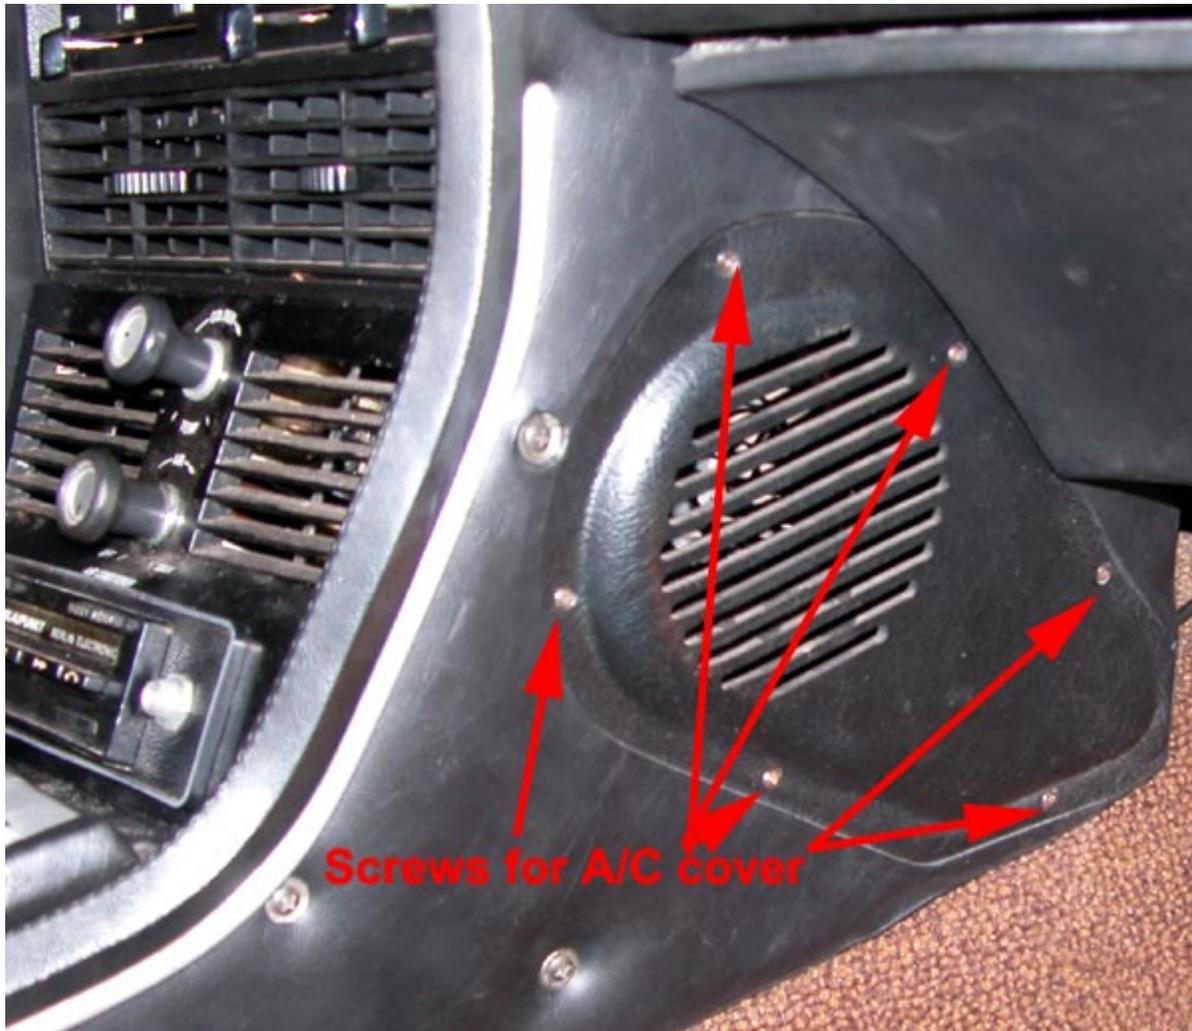
Console removal starts with removing the A/C air inlet covers (if you have A/C). Six little screws hold the cover on. The procedure is the same for both sides.

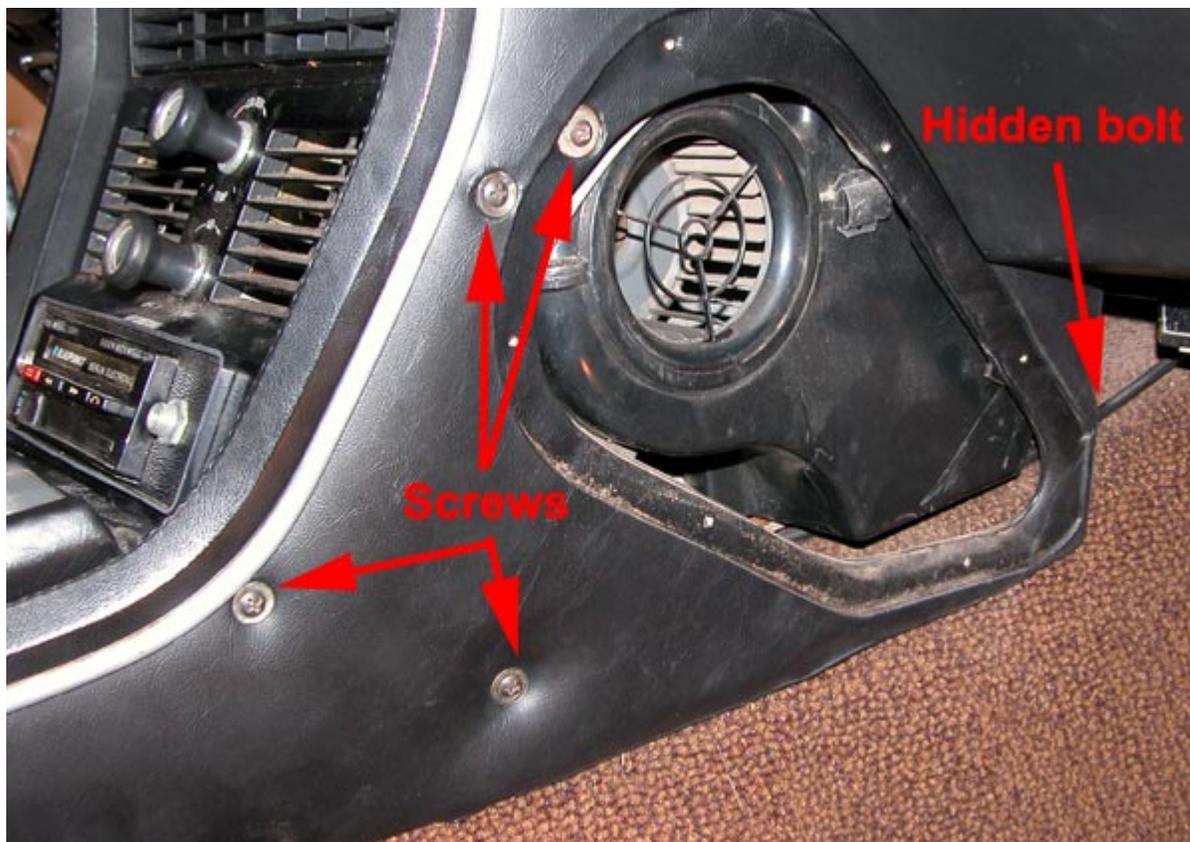
Then you need to remove four screws and one well hidden bolt. There is a nut on the bolt that is not attached to anything. Be careful or you will drop it and have a difficult time finding it.

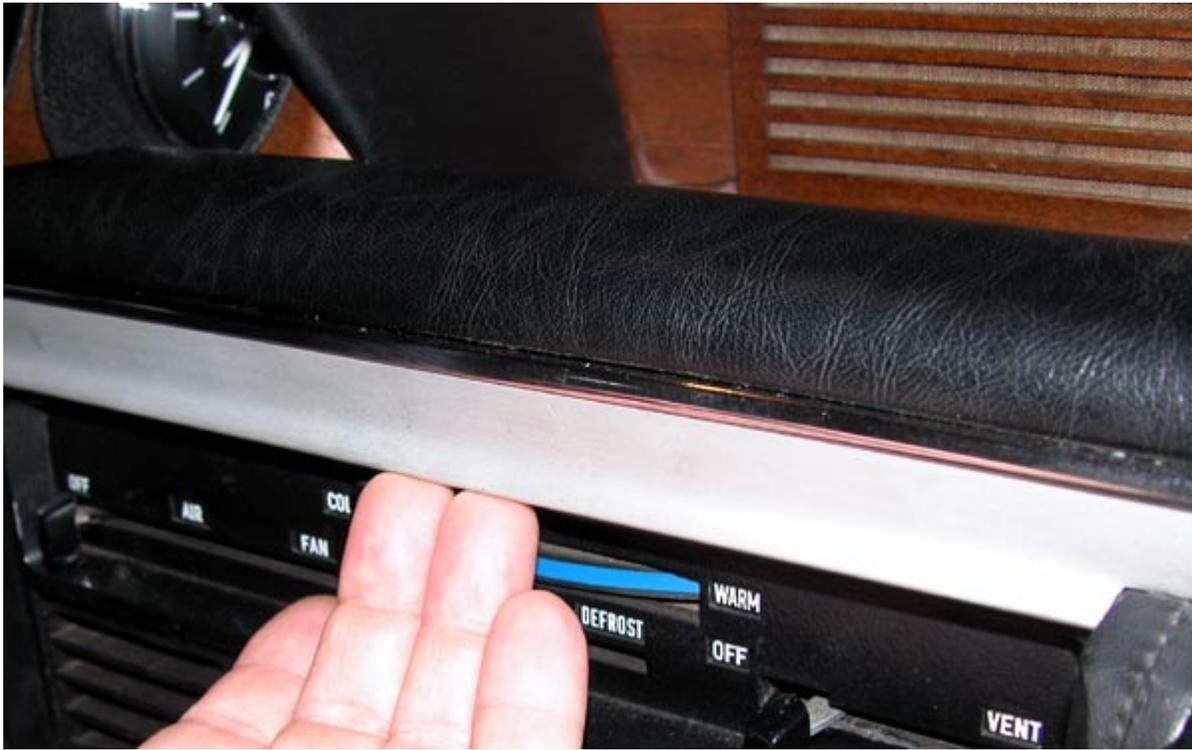
I removed the lip at the back of the dash shelf for more access. If you put your fingers under the trim and carefully pull, it will come off the dash. It is only held on by little push in studs. The stainless steel at the top of this trim comes off easily. Now is the time to polish it.

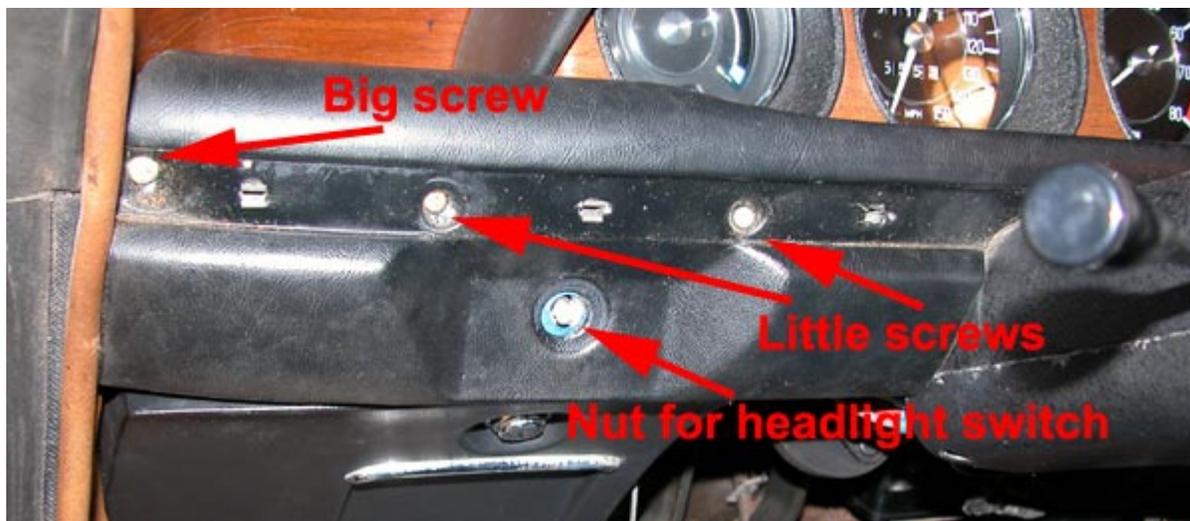
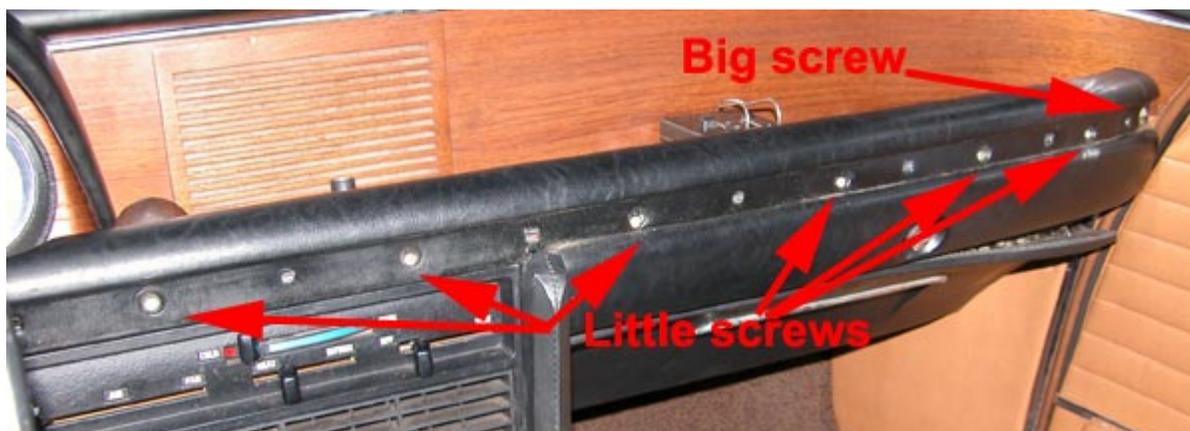
Once the trim is off you can see the big screws at each end, and the little screws that hold the lip onto the dash. With this part off it was much easier to get the sides of the console off.

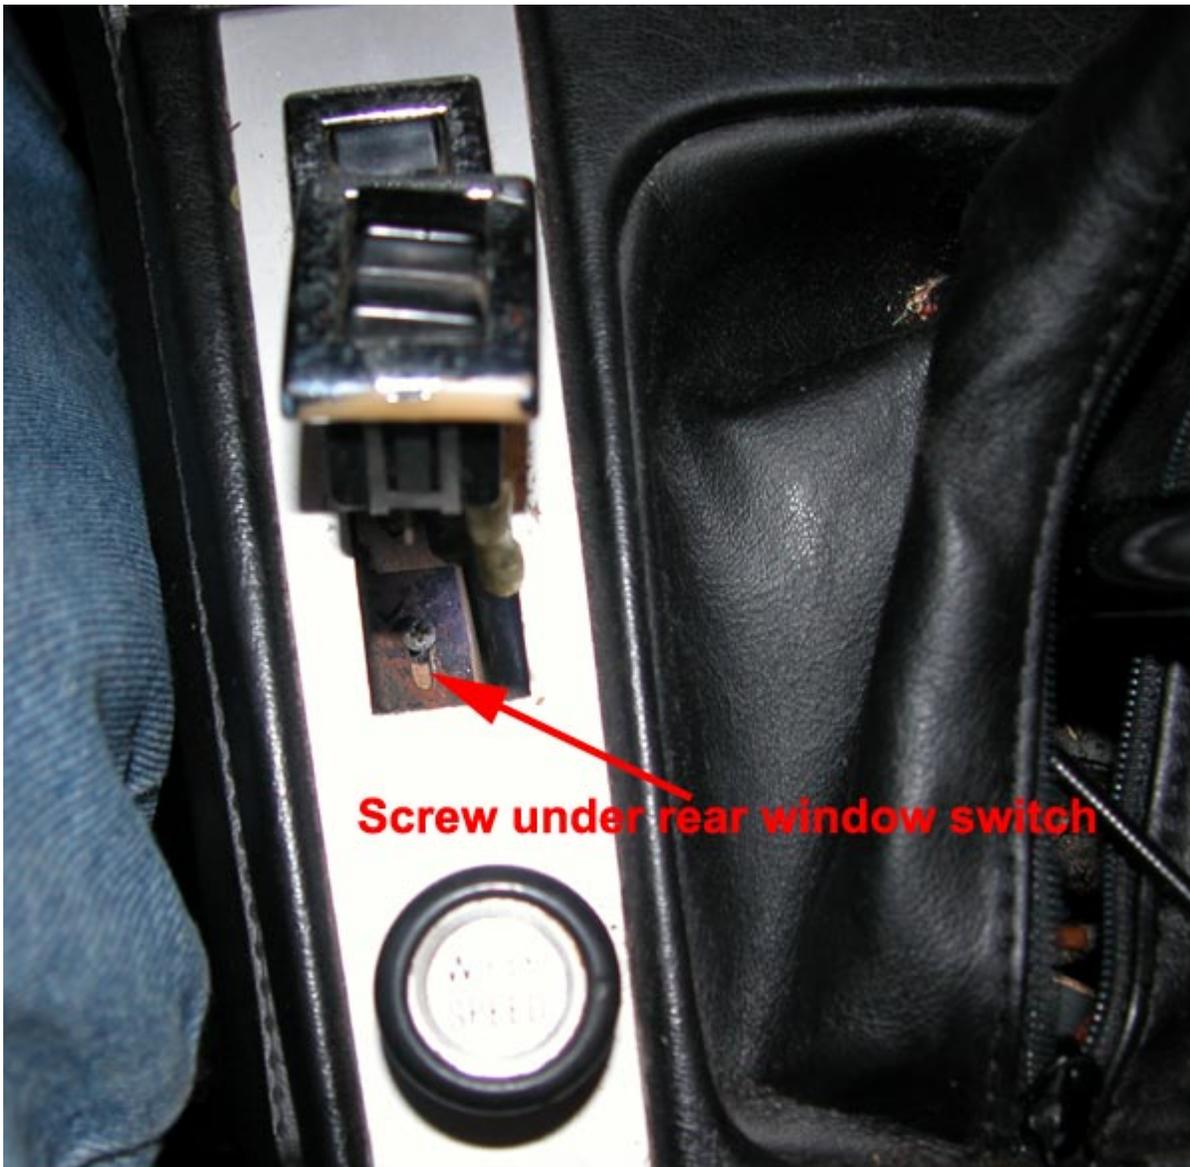
There is a screw under each rear window switch. Carefully lift out the switch. I found it easier to unzip the shifter boot and push the switches up from below. With the switch out of the way you can see the screws.

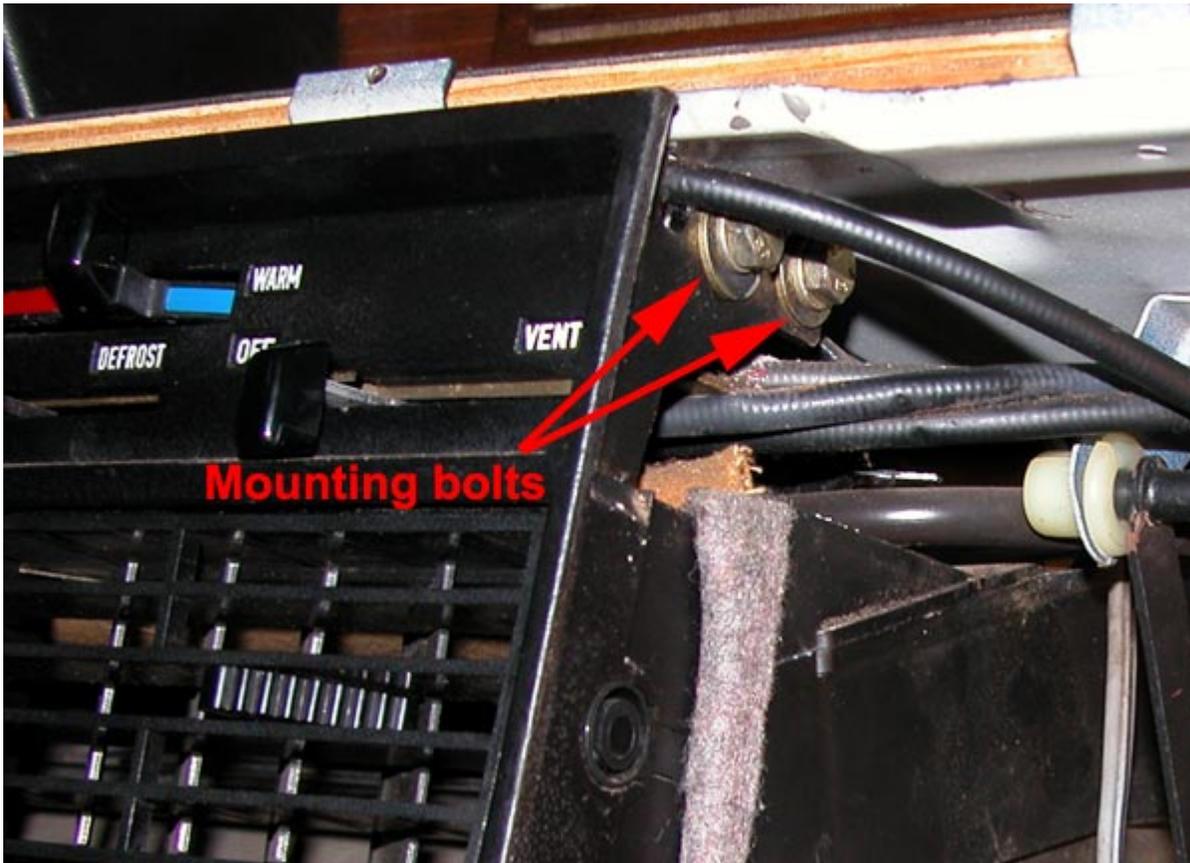
I removed the heater controls for more access, just like it says in the manual. There are two bolts on each side. The front right bolt on mine was missing. I dug through the hardware that I found in the car when I fixed the floor and there it was. The threads in the captive nut were damaged so Fritz threw it on the floor.

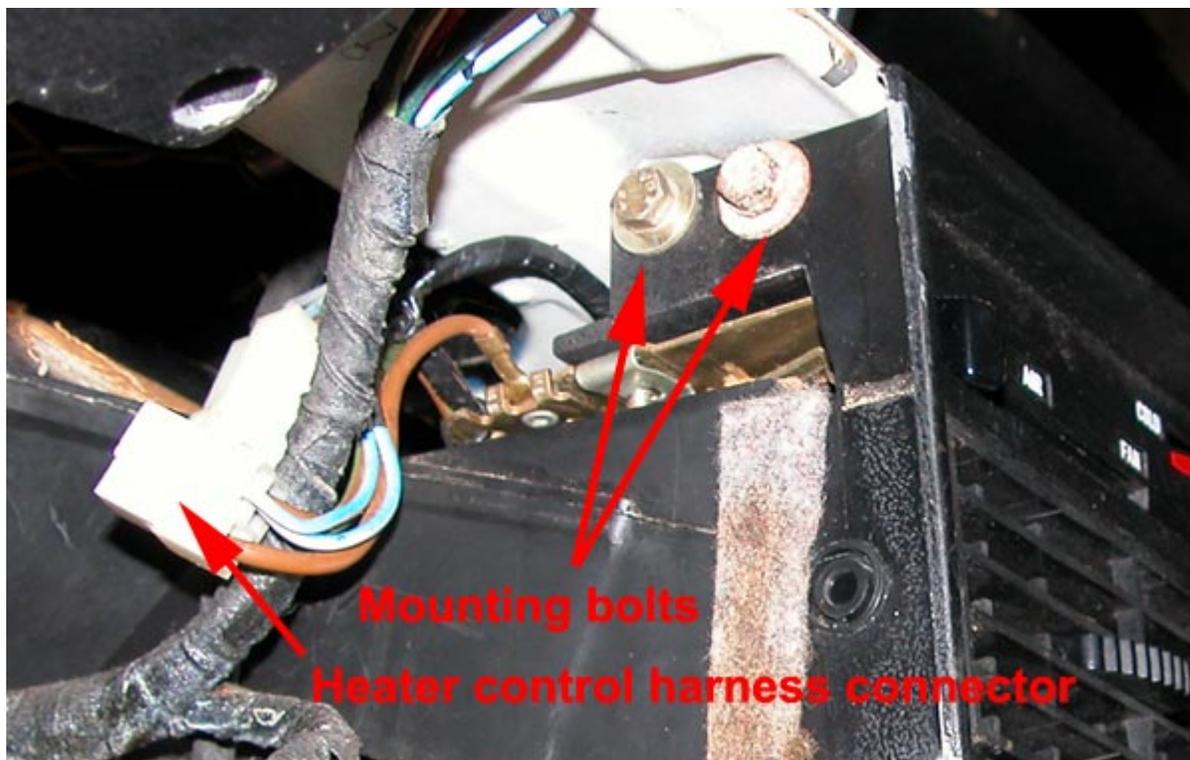
There is a wire harness at the left that needs to be disconnected. I didn't completely remove the controls because I didn't want to readjust all of the control cables.

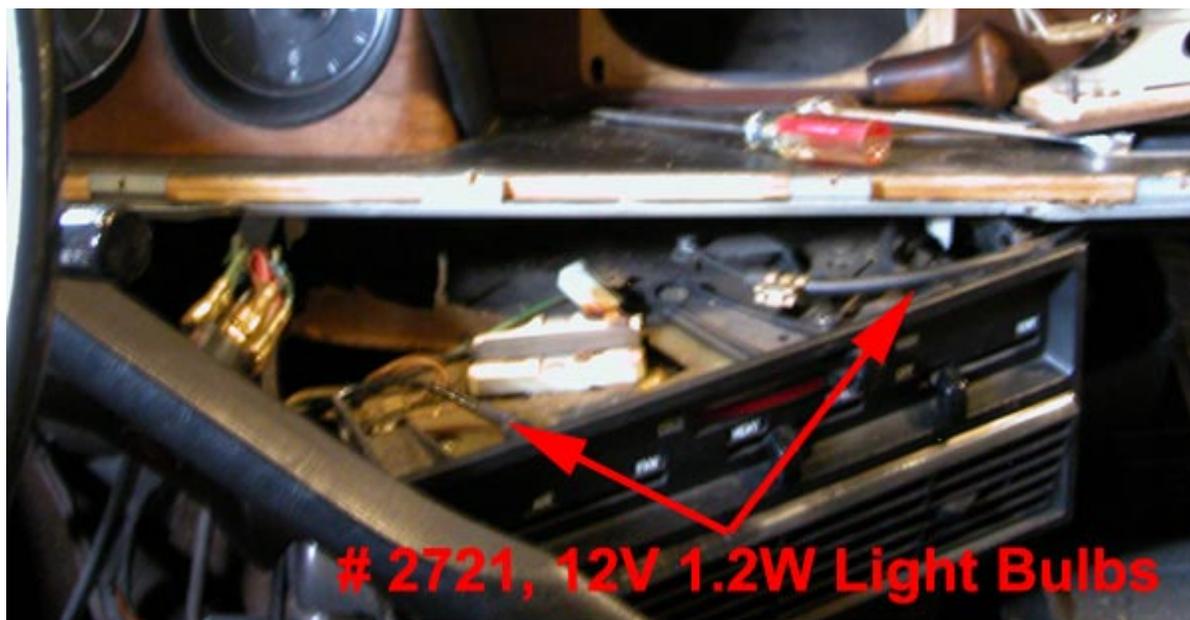
I was a little surprised to see that there were bulbs for the heater controls. Collective wisdom from a discussion on the E9 forum is that '73 and newer coupes have illuminated heater controls. My '72 has lots of '73 parts so that fits. The bulbs were #2712, 12V 1.2W. The local parts store had them for \$3.80 per pair. They also fit Mercedes, Audi, Volvo, Porsche, etc. so they should be easy to get.

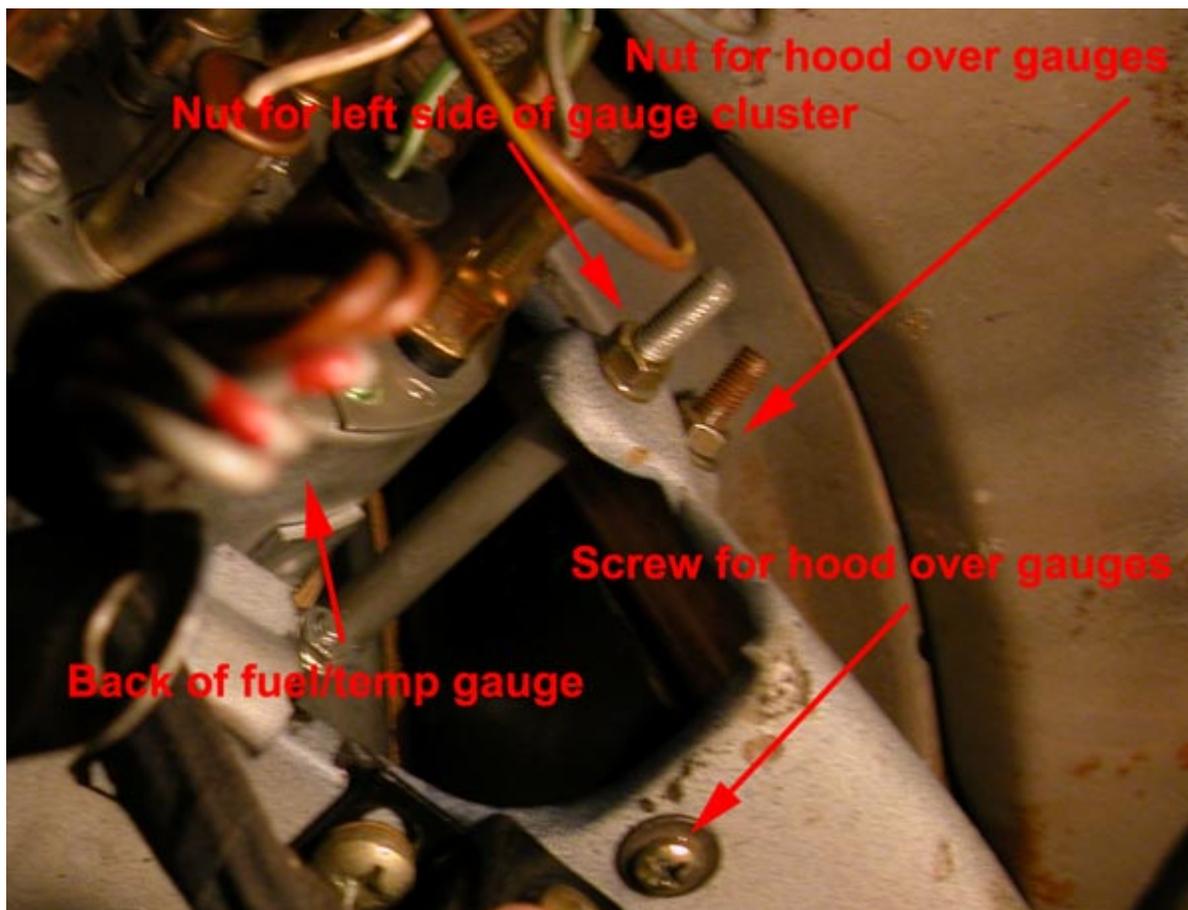
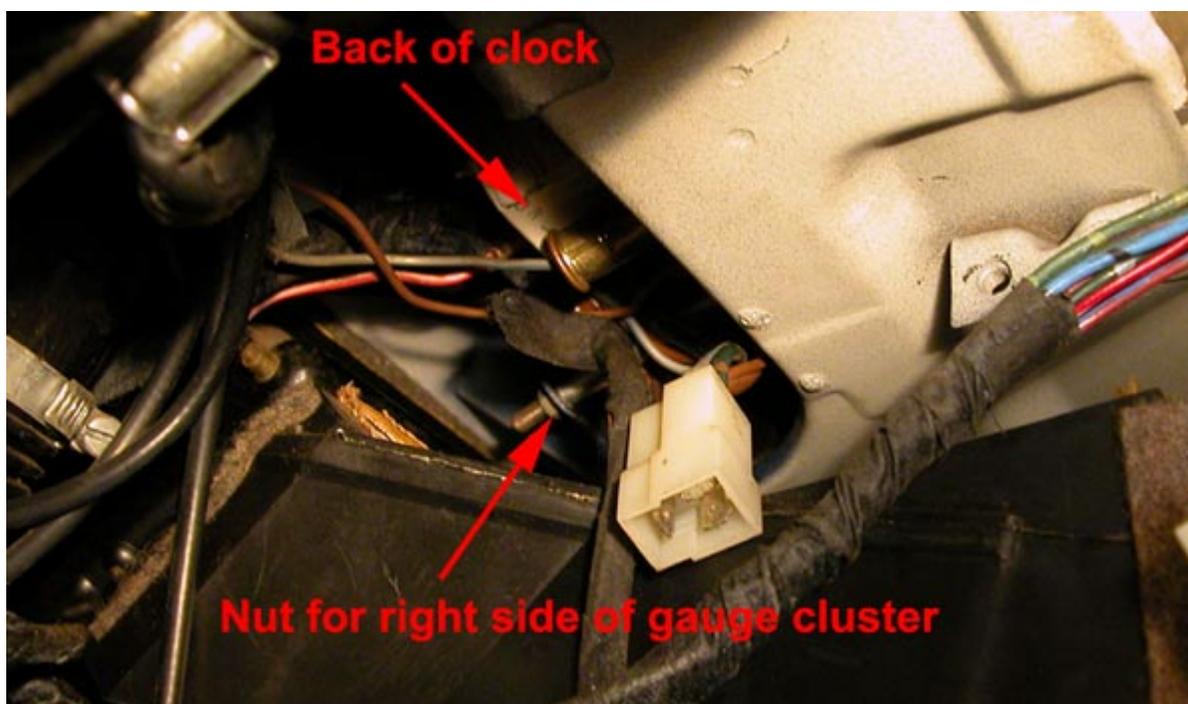
Once the console and lower dash panels are out of the way you can get to the nut and screw that hold the left side of the hood over the gauges, and to the two nuts that hold in the gauge cluster. You also need to disconnect the speedometer cable. My speedometer cable had a crew on collar that took a few turns to get off. I have been told that some only need a 1/4 turn to be free.

If you pull and lift on the bottom left corner of the hood over the gauges you can get the stud to slide through the sheet metal, then the wood and then you can lift the left side of the hood just a little. Be careful! Once the left side of the hood was lifted I could pull the gauge cluster out enough to get a ratchet behind the dash to loosen nuts that hold in the gauges. As you are facing the front of the car you rotate the gauges just a little counter-clockwise and they will be free of the gauge cluster. I lifted the gauge cluster up and out of the way.

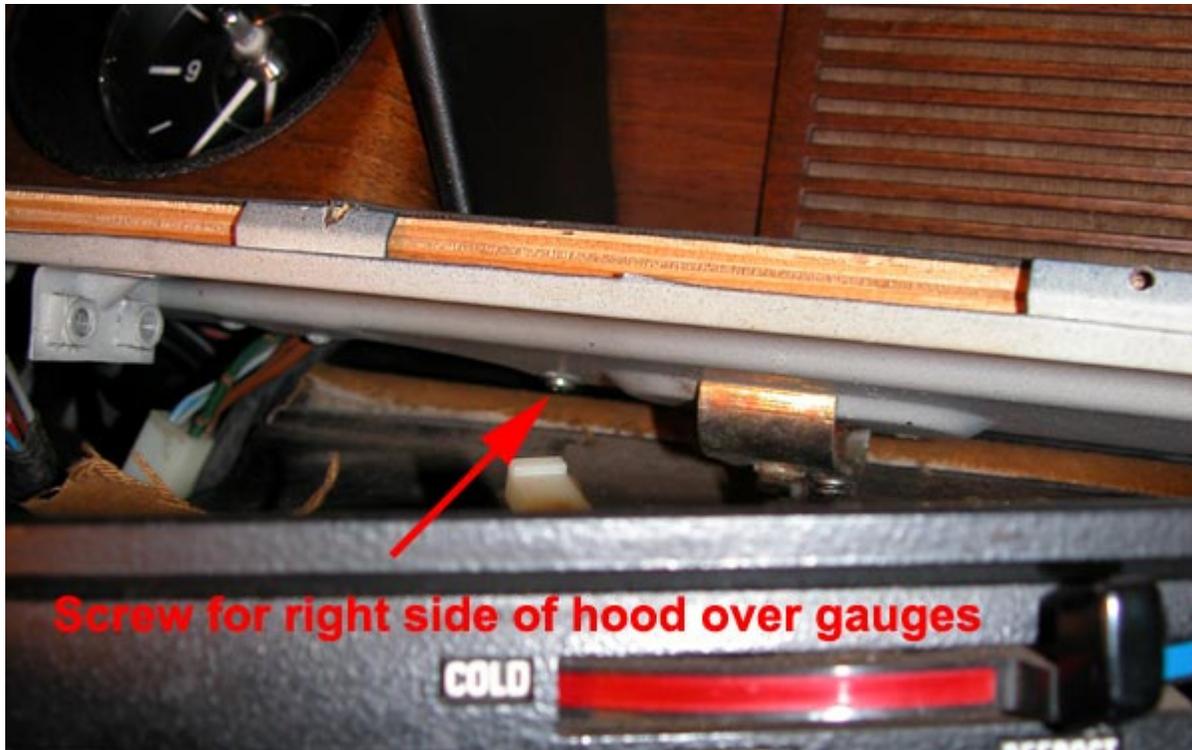
If you need a little more wiggle room in the hood that goes over the gauges then you can take out the screw at the right bottom of the gauge hood. See the picture below. There is also a nut on a stud at the back right of the gauge hood. I think that I could get to it through the speaker hole. I didn't need to take it off to get the gauge cluster out on mine.

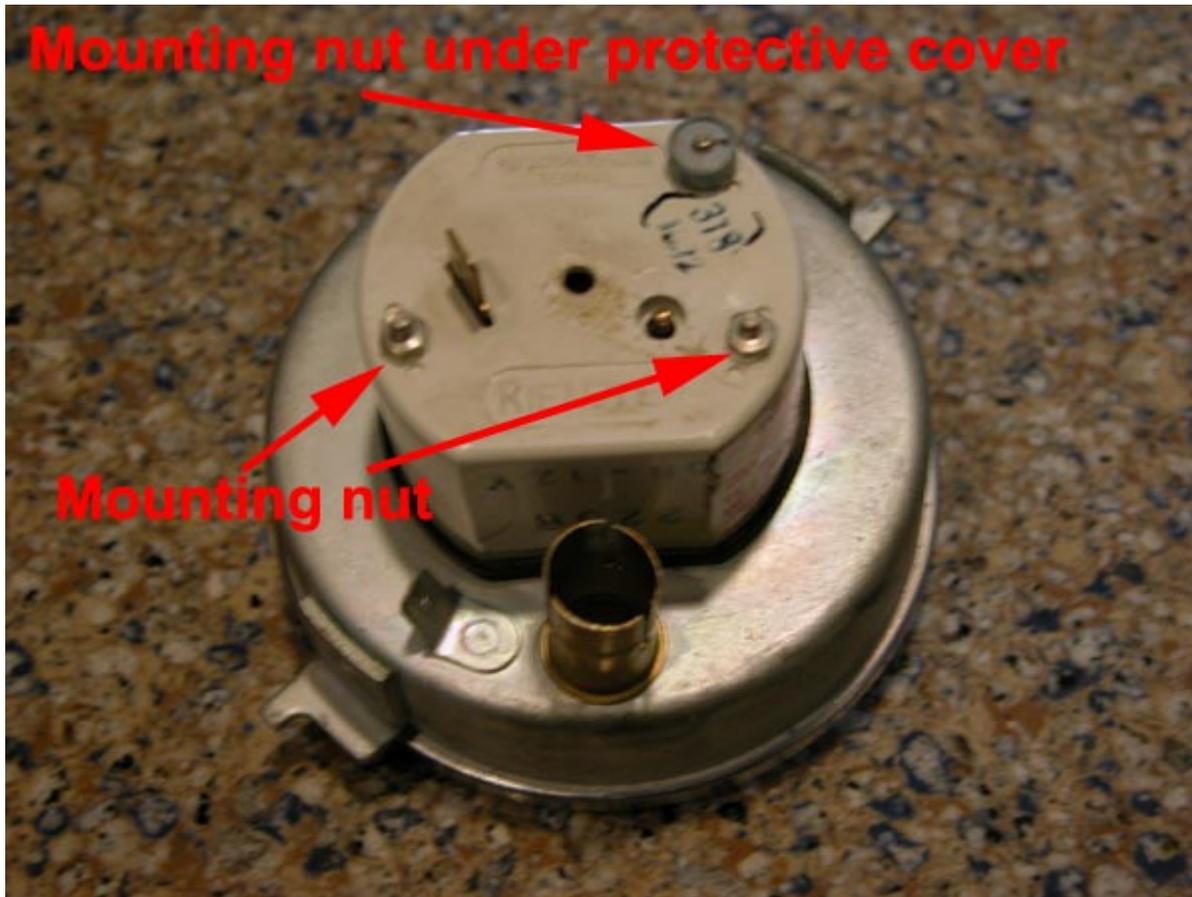
The back of the clock looks like the picture below. You need to remove three nuts to get the plastic cover off. One of the nuts is under a plastic cover. I just turned the grey plastic part around the nut. Two little tabs on the protective cover broke. Since it is way out of warranty I don't care.

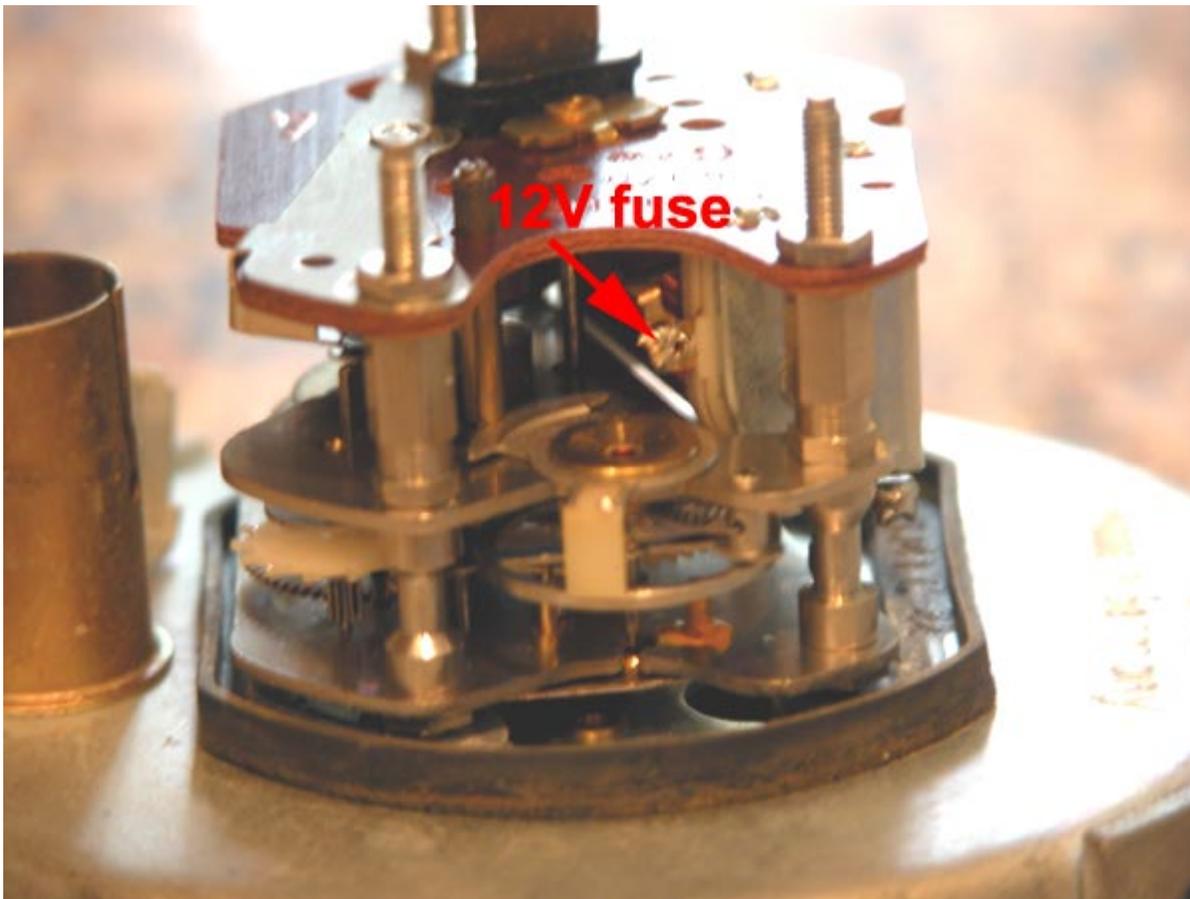
Once you get the plastic cover off it looks like the picture below. There is a metal strip that runs under the circuit board and is supposed to connect the 12V feed tab to the winding coil. The metal strip is connected to the tab on the coil by a small piece of very low temperature solder. Mine was melted and the metal strip had sprung away from the tab. I held the strip in place and used a little dab of solder to hold them together. The clock works great now.
